Eaton® Fuller® Clutches

Failure Analysis Guide
All Clutch Models

CLSL-1271

November 2002

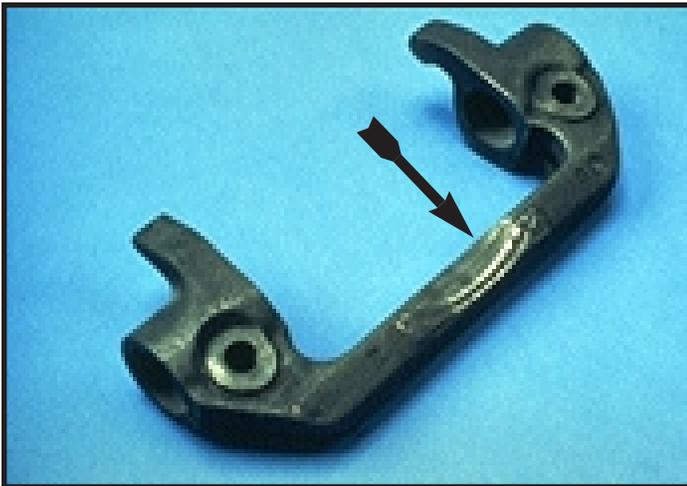
Figure 1

FAILURE—YOKE BRIDGE RUBBING INTO COVER

The arrows in figure 1 and 2 show the areas of contact between the release yoke bridge and the clutch cover. Overstroking of the yoke, in an attempt to obtain the required 1/2" - 1" clutch brake squeeze, is a typical cause of this failure.

- Worn clutch brake
- Broken or missing clutch brake
- Worn or incorrect transmission bearing retainer cap (refer to figure 3)
- Excessive wear on release bearing wearing pads and/or the fingers of the yoke (refer to figure 79)
- Improper set up of the linkage system. Consult your O.E. service manual
- Incorrect yoke installed

NOTE: The clutch cover can be reused if above steps are corrected, a new yoke is installed, and there are no broken or cracked parts on the cover. The above failure is typically preceded by a noise complaint and/or vibrating clutch pedal at the point where the clutch pedal is fully depressed. Depending upon the amount of wear (at the bearing cap and/or yoke fingers/wear pads), it may be possible to adjust the linkage to eliminate the noise complaint.

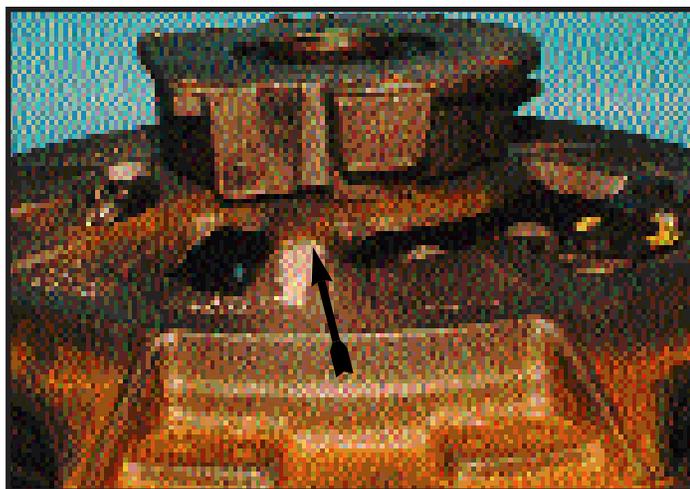
Figure 6

FAILURE - CRACKED / BROKEN CLUTCH COVER

Referring to the arrow in Figure 6, this brand new clutch (Easy-Pedal 1402 S.D.) was damaged during transmission installation. More specifically, the release yoke “fingers” were elevated to the “straight out position” and were allowed to jam into the clutch cover. Subsequent damage might be a broken finger(s)(figure 5) or bent release yoke / cross shafts. As a result, it is important that these parts be inspected for damage (and replaced if damaged) before installing a new clutch.

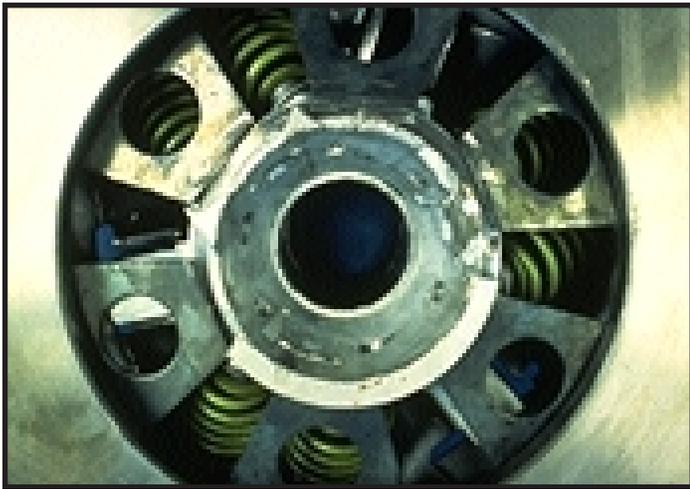
Figure 7 (SAS)

FAILURE—BROKEN RETAINER ASSEMBLY

Figure 7 shows what can happen when the levers break through the retainer's nose. The primary cause of this failure is allowing the transmission to hang unsupported in the driven disc during transmission installation.

NOTE: Refer to the Eaton Installation Instructions concerning clutch/ transmission installation.

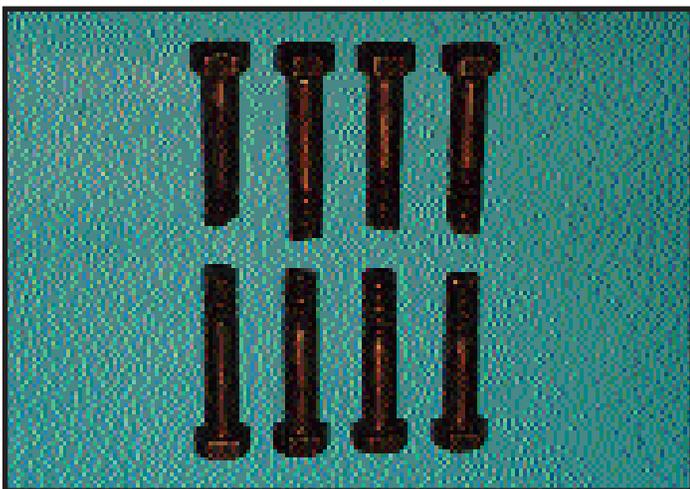
Figure 8

FAILURE - CLUTCH COVER DETACHED FROM FLYWHEEL

The broken mounting bolts, show in figure 8, are the direct result of insufficient torquing of these (8) bolts to the flywheel. More specifically, these bolts were loose enough to allow the clutch cover to hammer back and forth against each bolt until they broke. Also, the (8) mounting bolt holes in the clutch cover were "egg-shaped" as a result of the constant hammering.

Another potential cause of the above failure would be the over-torquing of the mounting bolts. Doing so can cause the bolts to fracture and eventually separate from the flywheel. Combining this scenario with low grade mounting bolts will increase the chances of failure.

NOTE: Refer to the Eaton Installation Instructions (packaged with each clutch) to determine the proper mounting bolt torque, minimum grade of bolt, etc., for the specific Eaton Fuller Clutch model you are installing.

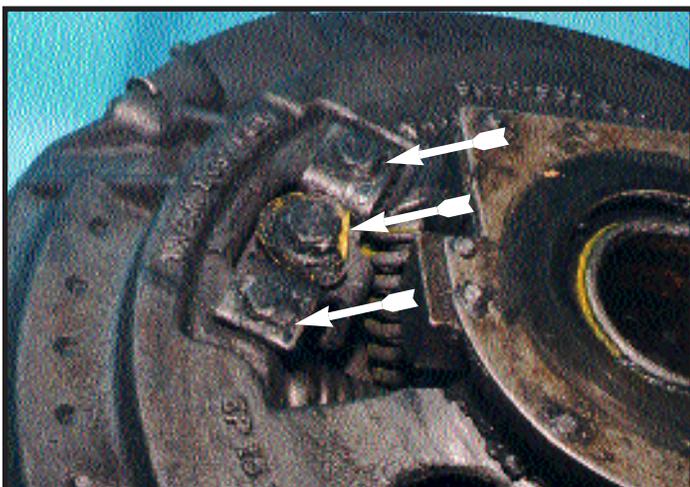
Figure 9

Additional damage occurred to both the clutch cover and the release yoke as a result of their interference with each other (refer to the arrows in figures 9 and 10). It is worth noting that this service clutch had accumulated 50,000+ miles before it failed.

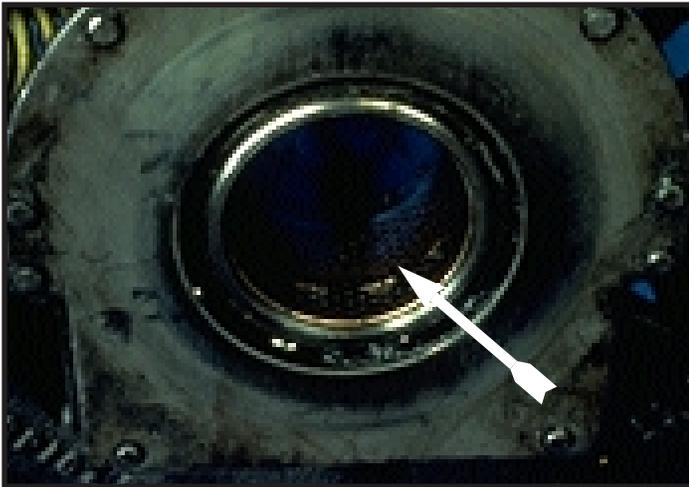
Figure 11

FAILURE—DAMAGED SLEEVE BUSHING

Failure to center the input shaft with the sleeve of the release bearing assembly, when installing the transmission, can cause this failure. If the transmission hangs up during installation, investigate the cause before proceeding as excessive force can damage the bushing (see arrow in figure 12). Allowing the transmission to hang unsupported in the sleeve bushing can damage the bushing. The arrow in figure 11 shows another example of sleeve bushing damage on a heavy duty clutch.

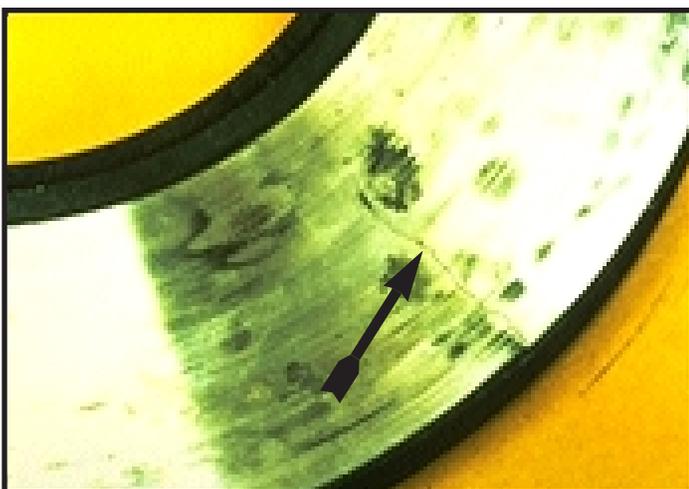
FAILURE—DAMAGED INTERMEDIATE OR PRESSURE PLATE

Figures 13 - 16 depict damaged clutch plates which resulted from an abnormal amount of clutch slippage/heat. Some causes of this abnormal slippage/excess heat can be one or more of the following: (1.) Incorrect clutch applications. In other words, the engine's torque rating exceeds the clutch's torque rating. (2.) Driver abuse. (refer to page 1 concerning the specific driver practices that can lead to excessive heat). (3.) Improper/ inadequate clutch adjustments. More specifically, operating the truck without free-play for extended periods of time; adjusting the clutch via the linkage instead of the required internal adjustment. (4.) Overloading of the vehicle.

Figure 13 is an example of a cracked pressure plate. The heat flow was so great that the metal could not dissipate it quickly enough.

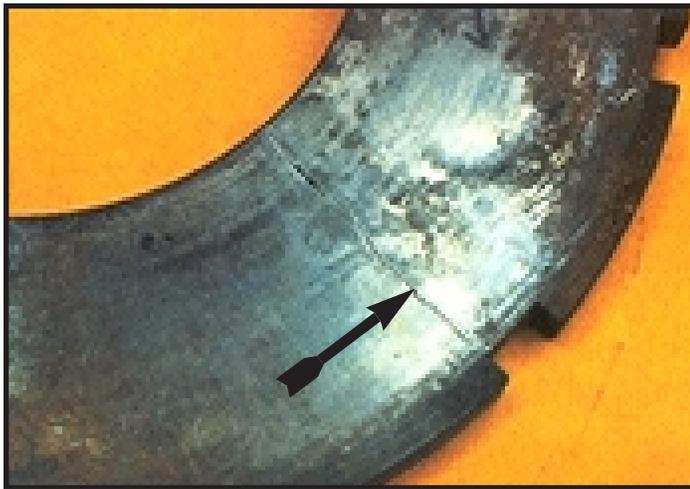
Figure 14 shows a broken intermediate plate. As in the previous example, the heat flow was so intense that the metal could not disperse the heat quickly enough.

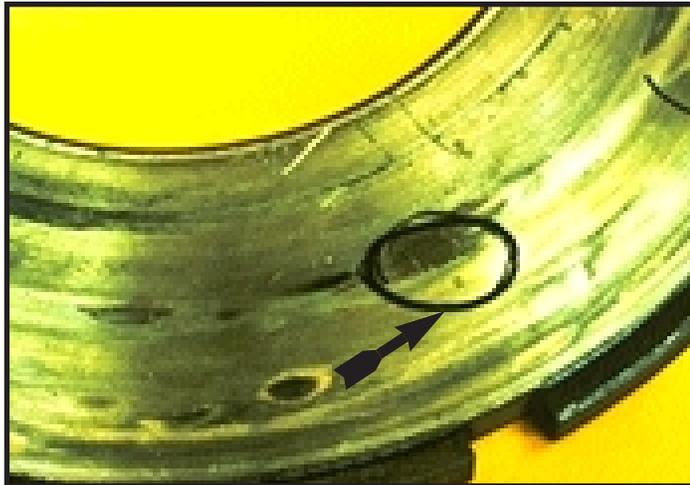
Figure 15

In figure 15, an area of the intermediate plate has been circled to reveal the damage of heat checks. These heat checks are actually small cracks in which their raised ridges are capable of shaving off the facings of the driven disc.

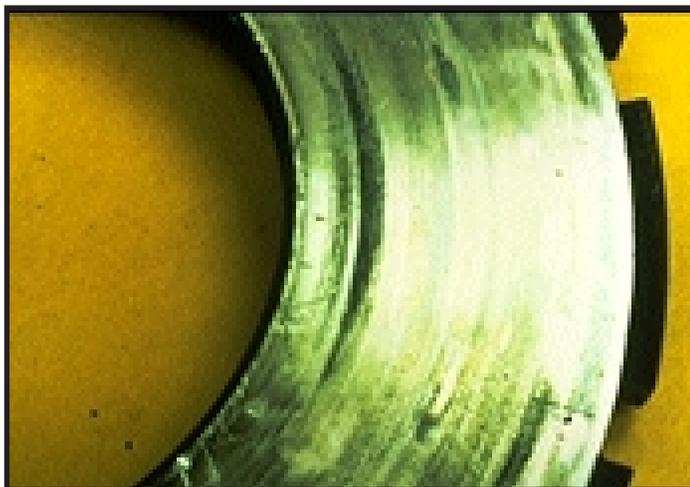
Figure 16

Finally, figure 16 reveals an example of a burned or scorched intermediate plate in which the metal became so hot that it began to flow. The typical evidence of such a failure will be one or more of the following: (1.) High and low spots on the plate, (2.) Partial transfer of the facing material (ceramic or organic) from the driven disc onto the plate, (3.) A blue discoloration throughout the failed part.

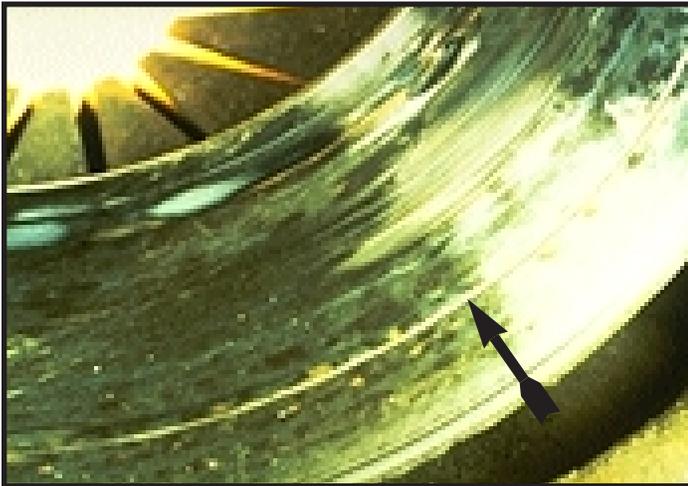
Figure 17

FAILURE—GROOVED PRESSURE PLATE

The groove (see arrow in figure 17) worn into the face of this pressure plate was caused by the rivets of the driven disc facing. (For the resultant disc failure, see the description under figure 70). The same damage can occur on both the intermediate plate and flywheel. A surface that is grooved can damage the new driven discs that are installed. As a result, a new clutch assembly should be installed. Refer to the O.E. service manual concerning flywheel resurfacing.

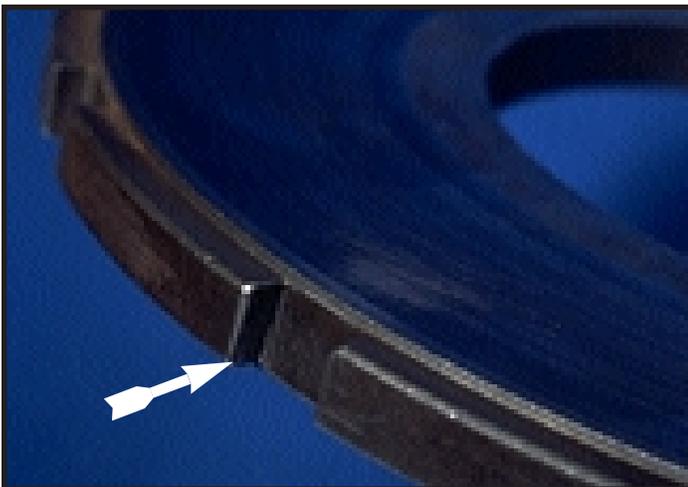
Figure 18

FAILURE—COCKED DRIVE PINS (14" POT-STYLE CLUTCHES ONLY)

The groove worn in the face of the drive pin slots are on the upper section of the face on one side of the slot (see arrow in figure 18) and on the lower section on the opposite side of the slot. This indicates that the drive pins were cocked and causing the intermediate plate to hang-up. This will cause release problems and therefore hard shifting. Do not file the slots of the intermediate plate to correct the problem. Instead, you must reset the drive pin(s) until they are square to the flywheel.

IMPORTANT: Always install new Eaton drive pins when installing a new Eaton Fuller 14" heavy duty Clutch. This is important because worn drive pins (against the new intermediate plate slots) can prevent the clutch from releasing cleanly. Also, ensure that the drive pins are set squarely to the flywheel's friction surface (refer to the Eaton Installation Instructions packaged with each Eaton Fuller Clutch). Failure to set each drive pin squarely is the most prevalent reason for a "poor release complaint" on a recently installed clutch. (Angle Spring and Easy-Pedal Plus 1402)

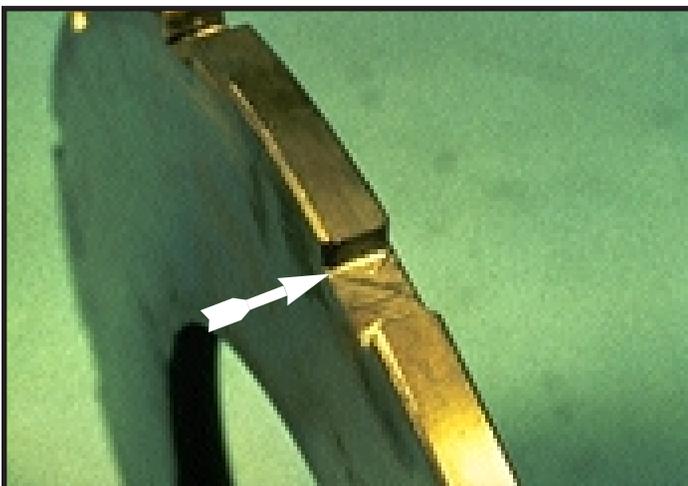
Figure 19

FAILURE—FILED DRIVE SLOTS

As indicated by the shiny areas on the drive slots, (see arrow figure 19) the slots of this intermediate plate were hand filed. Eaton does not recommend this practice since it can cause unequal loading on the drive pins in the flywheel. Instead, Eaton recommends that the drive pins be checked for squareness to the flywheel friction surface and reset if necessary (see Eaton Installation Instructions).

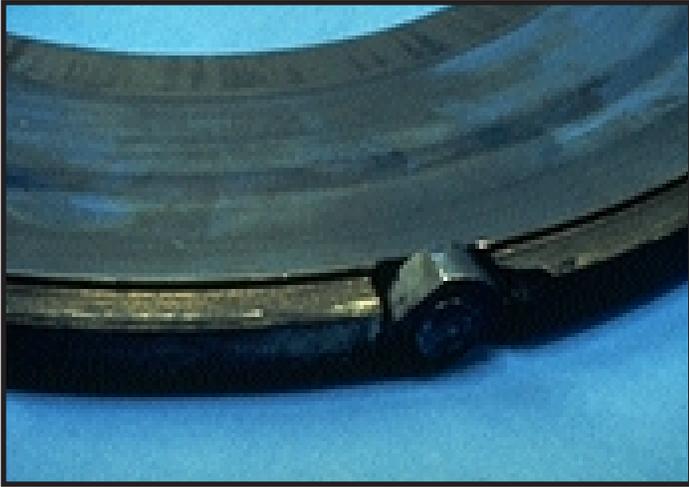
FAILURE—BROKEN DRIVE PINS & WORN/BROKEN DRIVE SLOTS (14" POT - STYLE CLUTCHES ONLY)

Figure 20 shows a broken drive pin head that has become wedged into the intermediate plate's drive slot. Figure 21 is the same intermediate plate but with excessively worn and broken drive slots. Figure 22 shows a broken drive pin. The above failures can be caused by one or more of the following:

- Failure to use the anti-rattle springs packaged with each super-duty clutch
- Misapplication of the clutch
- Unequal loading on the drive pins as a result of filing the drive slots.

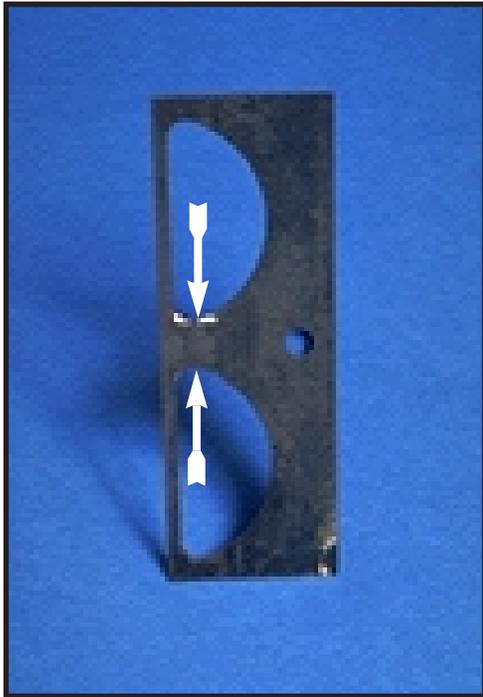
Figure 23

FAILURE—ANTI-RATTLE SPRINGS WERE INSTALLED BACKWARDS

As shown in Figures 23 and 24, the intermediate plate was “hanging up” at the corners of the open sections of the anti-rattle springs. The driver’s complaint resulting from this failure was a clutch that would not release. It is important that the rounded sections of the anti-rattle springs be installed TOWARDS the fly-wheel/engine.

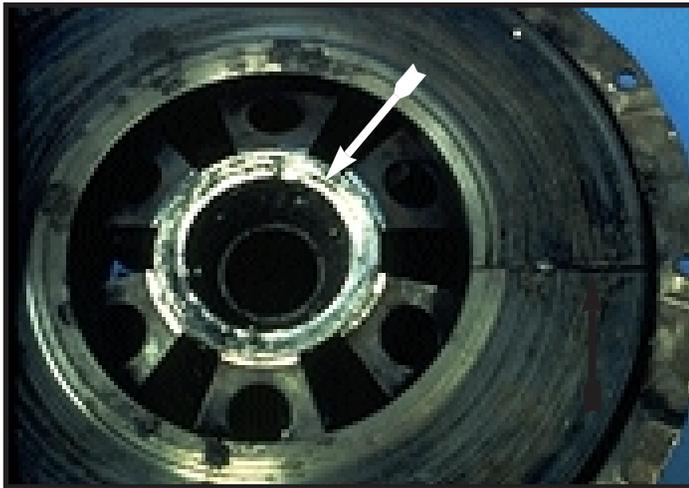
FAILURE—INTERFERENCE BETWEEN RETAINER ASSEMBLY & REAR DISC RIVETS

Figure 25 shows the damage done to the nose of the retainer assembly (see white arrow) due to contact with the disc rivets. Figure 57 shows the resulting damage done to the rear disc. Adjusting the clutch externally (with the linkage) instead of internally (rotation of adjusting ring) will cause the retainer sleeve/release bearing assembly to move too far forward as the clutch wears, leading to this failure.

An additional result from the above failure is that while the clutch is engaged, it can begin to slip due to the unloading condition created by the disc and retainer interference. This in turn will create excessive heat and can cause the pressure plate to break (see figure 25, black arrow on pressure plate) and /or the ceramic buttons to separate from the disc (see figure 58). The above failure may also be preceded by a noise complaint.

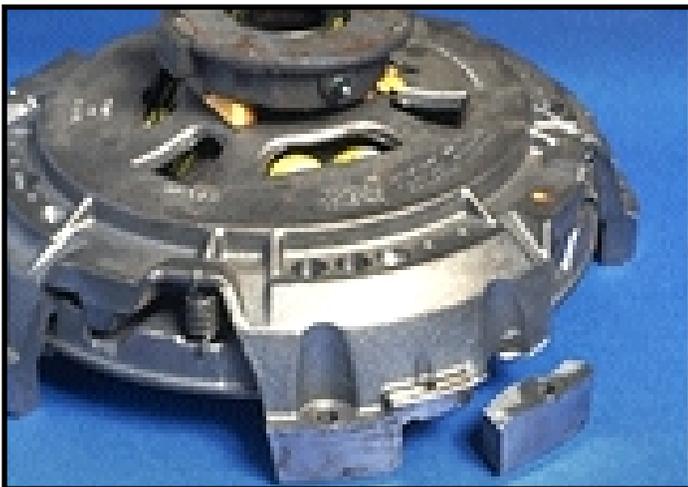
Figure 26

FAILURE—BROKEN LEG

The photo in Figure 27 is a close-up of the broken leg shown in figure 26. The arrow in this close-up shows where the leg contacted the concrete floor after the clutch was dropped.

The use of “guide studs” plus a “hydraulic clutch stand” will help prevent this 150 lb. clutch from being dropped during installation and removal. **NOTE:** Eaton Clutch does not provide warranty coverage for this type of failure.

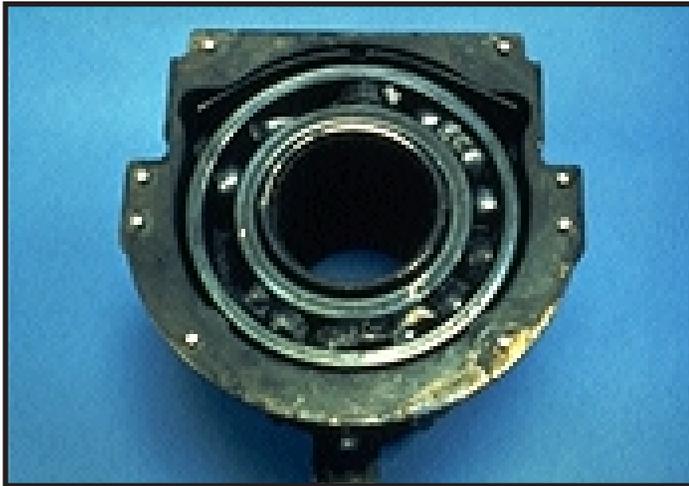
Figure 28

FAILURE—RELEASE BEARING

A failed release bearing (see figure 28) can usually be attributed to one or more of the following situations:

- A dry release bearing due to lack of periodic lubrication (does not apply to sealed bearings).
- Failure to fully release or riding the clutch pedal will place a constant thrust load on the bearing, (see arrows in figure 29) leading to higher temperatures and consequential loss of lubricant. Failure to maintain free play up in the cab can also cause this condition. Not only will the bearing begin to fail, constant contact in this area will cause both the release yoke fingers (figure 79), and the wear pads (figure 29), to wear excessively.

IMPORTANT: In order to determine the proper greasing techniques, be sure to consult the Eaton Installation Instructions packaged with each Eaton Fuller Clutch.

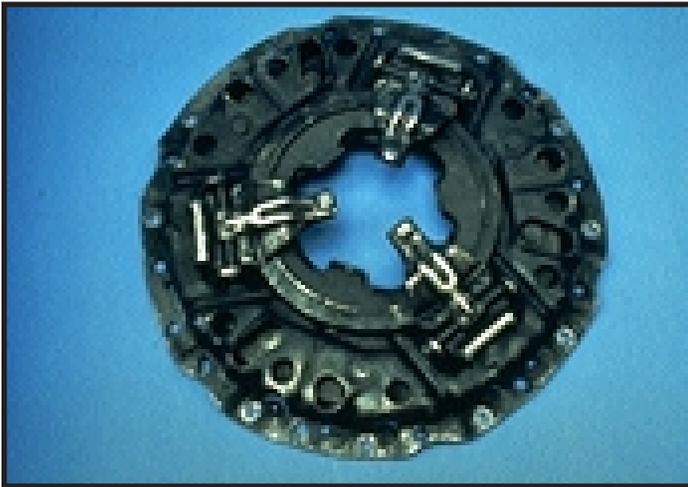
Figure 30

FAILURE—OIL SOAKED COVER

A leaking transmission or a leaky rear main engine seal can coat the clutch cover with oil, as indicated in figure 30 to the left. Figure 41 shows the disc which was run with this cover.

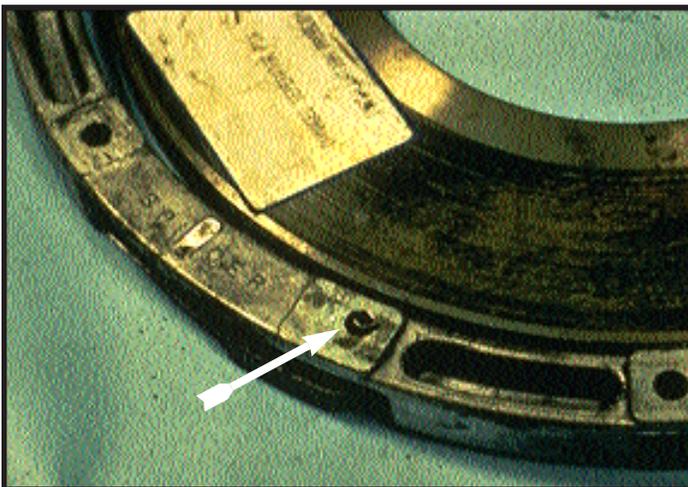
Figure 31 (SAS)

FAILURE—BENT/DAMAGED POSITIVE SEPARATOR PIN

The separator pin shown in figure 31 became damaged (bent) when it was dropped during clutch installation. To prevent this from occurring, Eaton recommends the use of two (2) guide studs when mounting the intermediate plate and clutch cover to the flywheel (refer to the Eaton Installation Instructions).

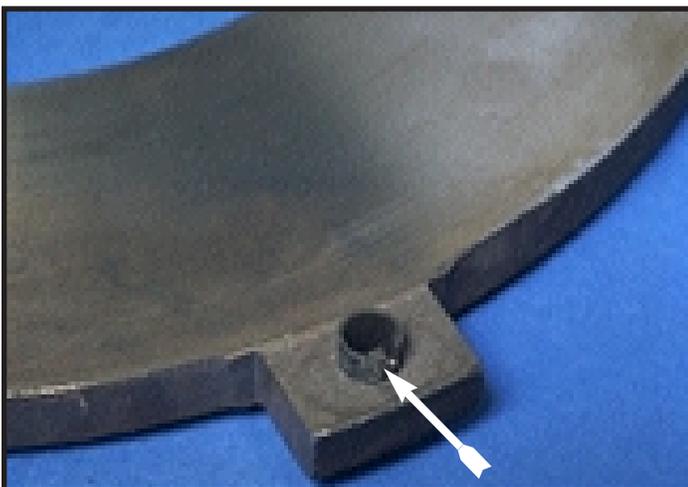
Figure 32 (EPP 15.5")

The damage done to the separator pins in figures 32 and 33 (see arrows) is the result of using the wrong tool combined with excessive force. All four pins (on each intermediate plate) were damaged. When “setting” the four (4) roll pins, the proper tool would be a 1/4” flat nose punch used in conjunction with a small hammer (to help ensure light taps).

A damaged pin(s) can prevent the intermediate plate from retracting evenly when the clutch is disengaged, leading to a “poor release” complaint from the driver. The same complaint can also occur if the mechanic forgets to “set” the four (4) positive separator pins upon installation of the clutch. In you forgot to set the separator pins *before* installing the transmission, you can still set them through the inspection opening of the transmission.

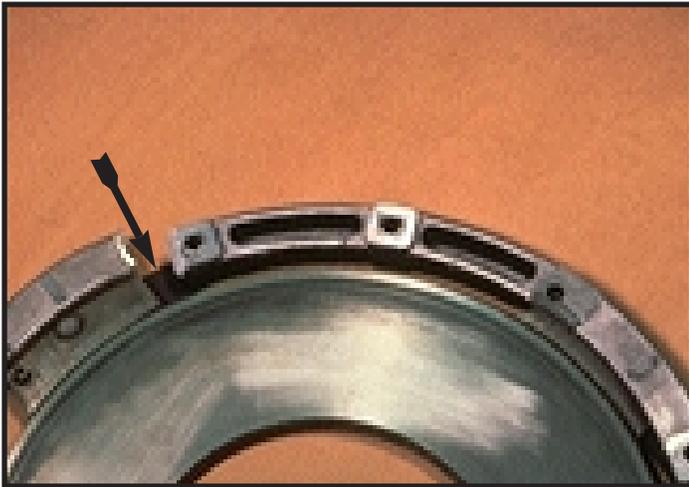
Figure 34 (SAS)

FAILURE—ALUMINUM SPACER RING ON THE INTERMEDIATE PLATE IS BROKEN (EATON FULLER SOLOS™ AND Stamped Angle Spring 1402 ONLY)

As shown in figure 34 (see arrow), the aluminum spacer ring broke when it was bolted up backwards onto the flywheel.

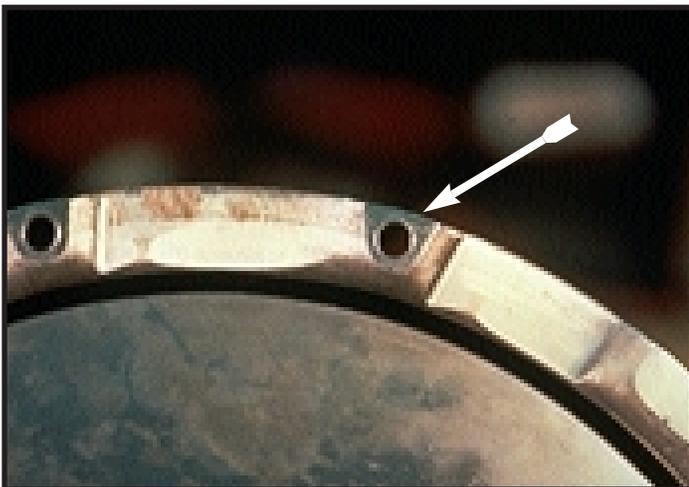
Figure 35 (SAS)

NOTE: The cover assembly mounting hole pads (see arrow in figure 35) have made an indentation (see arrow in figure 36) onto the spacer ring mounting hole pads (flywheel side). This evidence will confirm that the spacer ring/intermediate plate assembly was indeed installed backwards. The words “Flywheel side” (refer to figure 37 on the following page) will face the flywheel when properly installed. Mishandling of this assembly during installation and/or removal can also cause the spacer ring to break. Some results of installing the intermediate plate backwards are as follows:

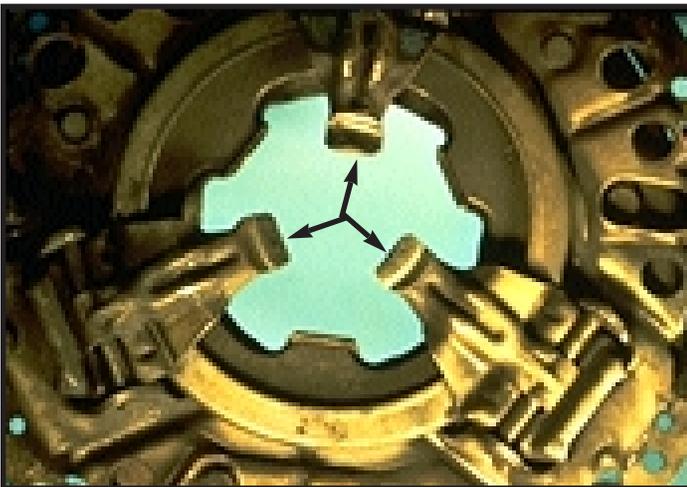
Figure 38 (AR)

FAILURE—LEVER WEAR

As indicated by arrows in figure 38, excessively worn levers are most likely the result of lack of maintenance. More specifically, lever wear can be the result of one or more of the following conditions:

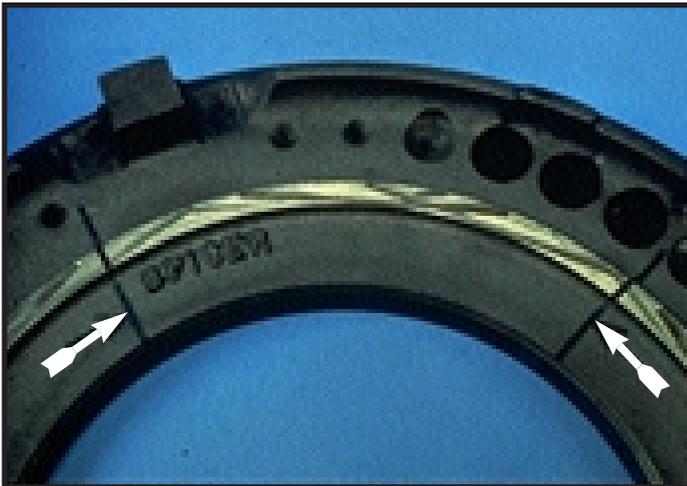
Figure 39 shows the back of the pressure plate. This clutch has been properly adjusted (internally, using the adjusting ring) because each of the 6 levers has more than one witness mark (or lever fulcrum point).

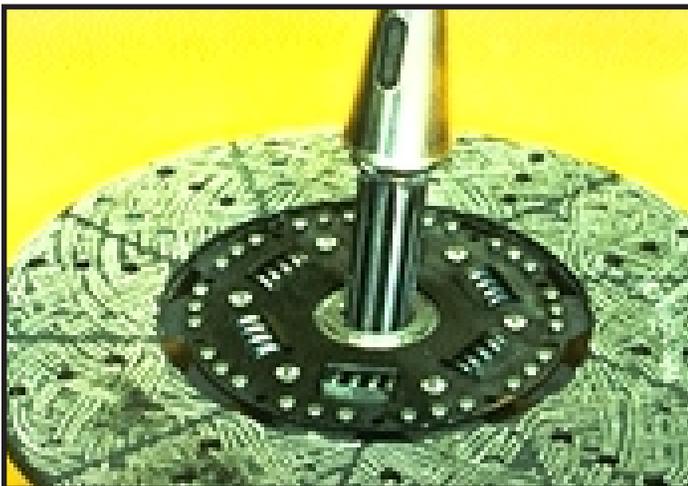
Figure 47

FAILURE—WARPED DRIVEN DISC

Shown in figure 47 is a brand new driven disc which was warped during transmission installation (as indicated by the dummy input shaft which is not perpendicular to the disc's hub). More specifically, the transmission was allowed to hang unsupported in the driven disc hub. A driven disc which has become bent due to improper installation techniques should not be reused because of the potential for a "poor release" complaint.

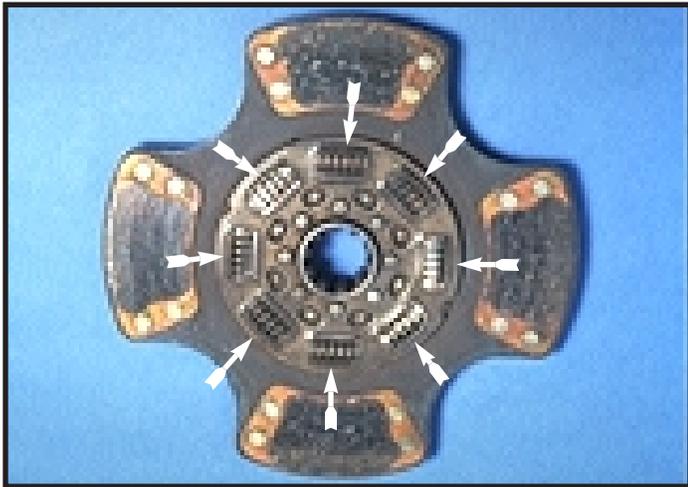
Figure 49: (EPP 14'')

2.) The damper springs (see arrows, figure 49 and 50) have been contacting the flywheel mounting bolts because the front driven disc was installed backwards. The driven disc (in figure 49) had been wearing for a period of time before the interference occurred (as indicated by the full wear pattern on the ceramic buttons) while the one in figure 50 was run for a very short period.

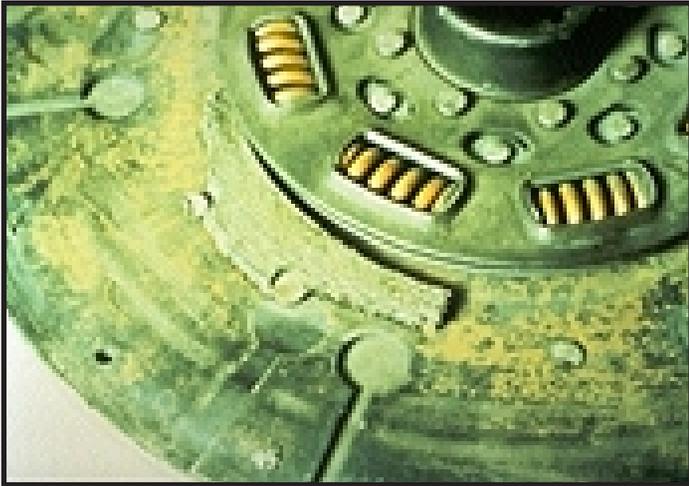
Figure 67: (AS)

Example: Coasting a tractor down an unloading ramp can burst a driven disc. See figures 67, 68, and 69.

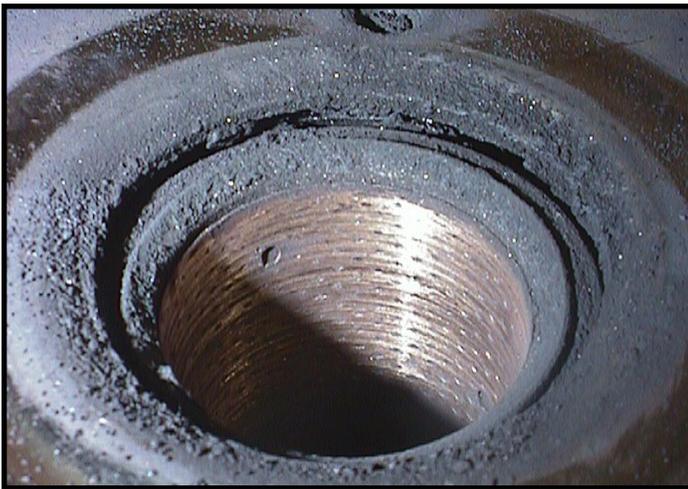
Figure 77

As shown in figures 77 and 78, incorrect lube or not enough lube can cause the failure. External contamination will also cause wear to the bushing. The transmission input shaft may be rough and require replacement. Use approved/compatible lube. (High quality N.L.G.I #2 or #3 lithium soap grease with E.P. additives. 325 degree operating temperature). Apply ample lube and let it flow out of the opening from the bearing housing. Apply additional lube onto the transmission shaft to insure the bushing will be lubed. Apply lube to the tips of the release yoke.

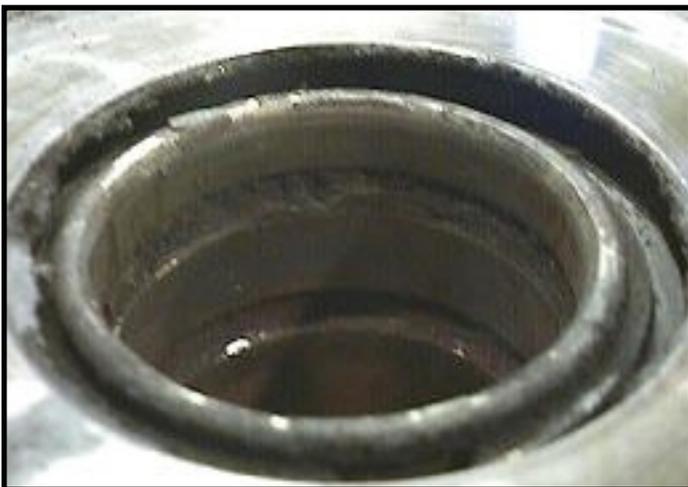
Figure 78

- A potential result of this wear is that the release yoke will force the bearing and sleeve assembly against the input shaft. Consequently, this “side loading” condition can damage the bushing, sleeve, and input shaft (see figure 78).
