Eaton® Fuller® Clutches

Failure Analysis Guide
All Clutch Models

CLSL-1271

November 2002

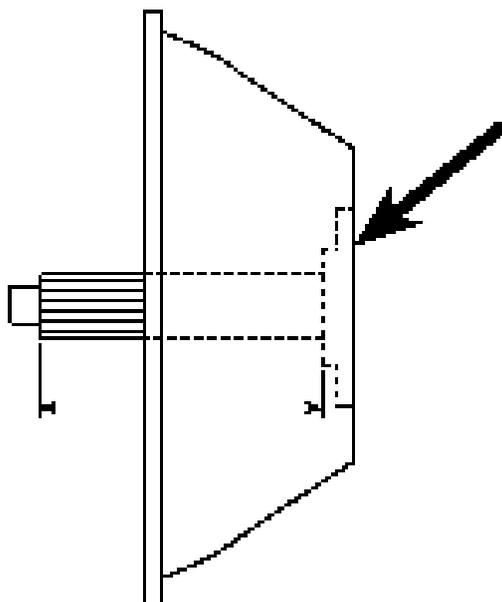
Figure 3

TRANSMISSION BEARING RETAINER CAP

Dimension A, Based on SAE standards, is 8.657" (219.9 mm) nominal, and should not be greater than 8.71" (221.5 mm) Ref. 1990 S.A.E. handbook 4:36.106

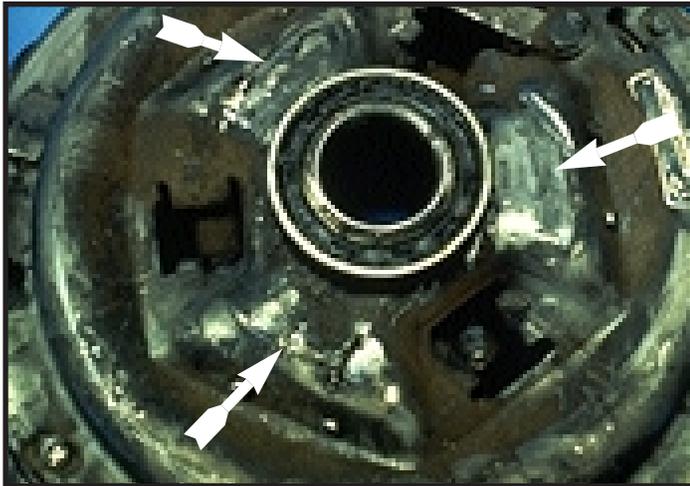
Figure 4

Figures 4 - 5 show the damage that results when the release yoke contacts the clutch cover. More specifically, the fingers have become pinched between the clutch cover and release bearing, resulting in one or more of the following:

- A broken /cracked release bearing housing (not shown)
- Damage to the clutch cover (see arrows, figure 4)
- Wear to the backside of the yoke fingers (see arrows in figure 5, top yoke)
- Broken yoke finger(s) (see arrow in figure 5 bottom yoke)

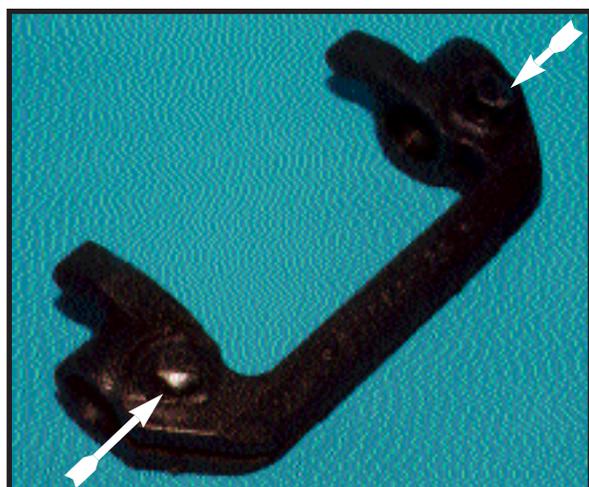
Figure 10

Additional damage occurred to both the clutch cover and the release yoke as a result of their interference with each other (refer to the arrows in figures 9 and 10). It is worth noting that this service clutch had accumulated 50,000+ miles before it failed.

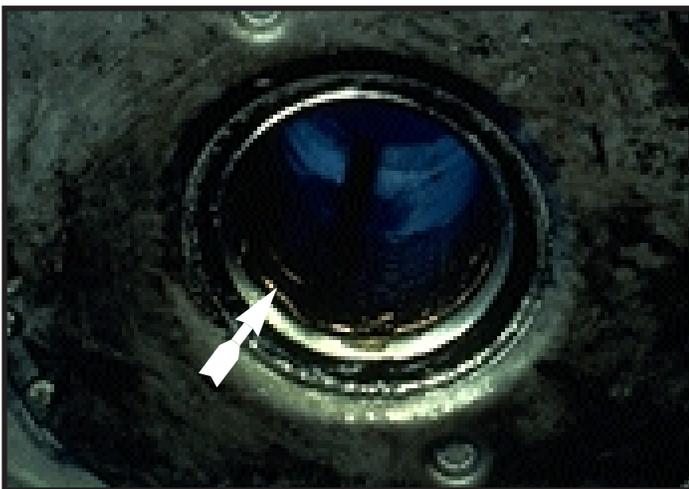
Figure 12

Failure to center the input shaft with the sleeve of the release bearing assembly, when installing the transmission, can cause this failure. If the transmission hangs up during installation, investigate the cause before proceeding as excessive force can damage the bushing (see arrow in figure 12). Allowing the transmission to hang unsupported in the sleeve bushing can damage the bushing. The arrow in figure 11 shows another example of sleeve bushing damage on a heavy duty clutch.

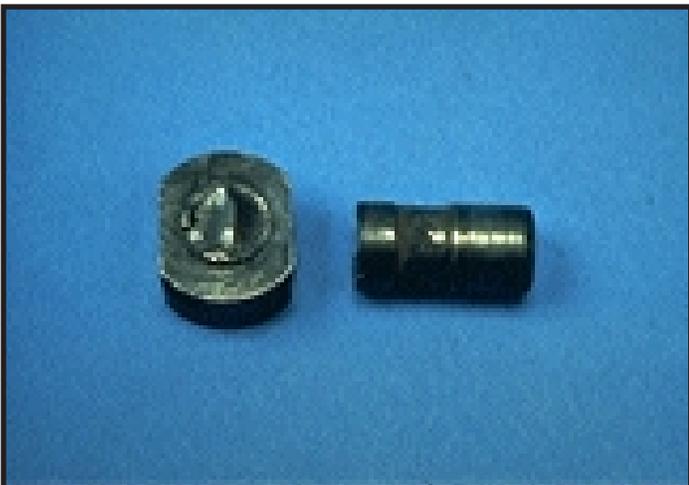
Figure 20 shows a broken drive pin head that has become wedged into the intermediate plate's drive slot. Figure 21 is the same intermediate plate but with excessively worn and broken drive slots. Figure 22 shows a broken drive pin. The above failures can be caused by one or more of the following:

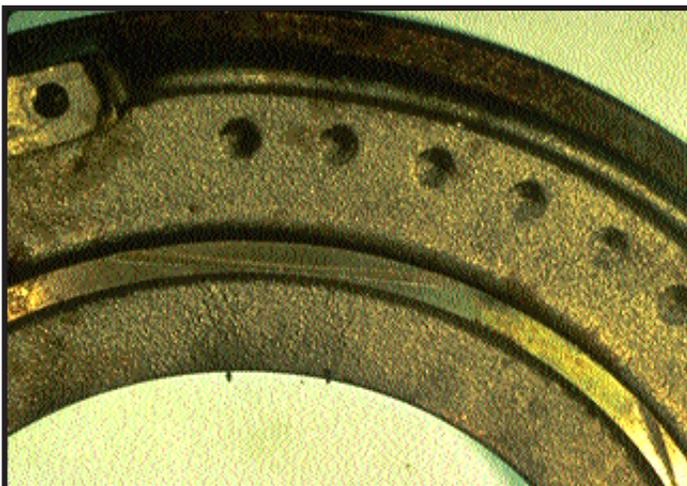
Figure 40 depicts a clutch that **has not been** adjusted properly. As shown, there is only one witness mark per lever indicating that the clutch was improperly adjusted using the linkage.

⚠ WARNING: Continually adjusting for clutch wear via the linkage can lead to the failures shown in Figures 4, 5, 25, and 57-58.

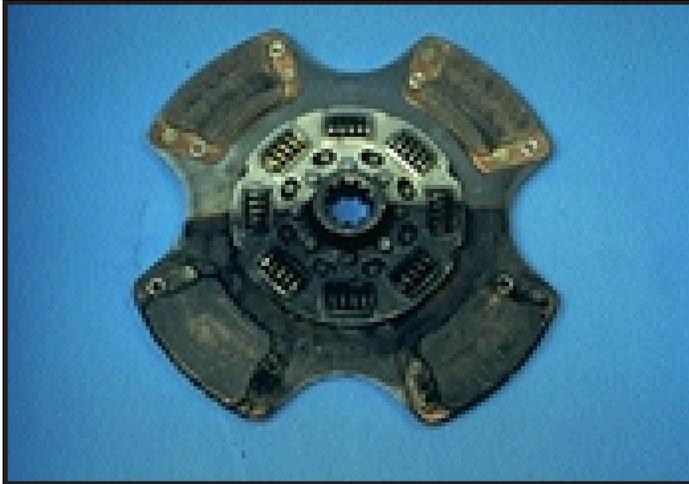
A leaking transmission or a leaky rear main engine seal can coat the clutch cover with oil, as indicated in figure 30 to the left. Figure 41 shows the disc which was run with this cover.

Furthermore, oil on the disc buttons can cause the clutch to release poorly due to increased drag, and/or chatter/slip during engagement.

NOTE: Eaton does not recommend the reinstallation of any discs that are oil soaked because the button facings cannot be satisfactorily cleaned.

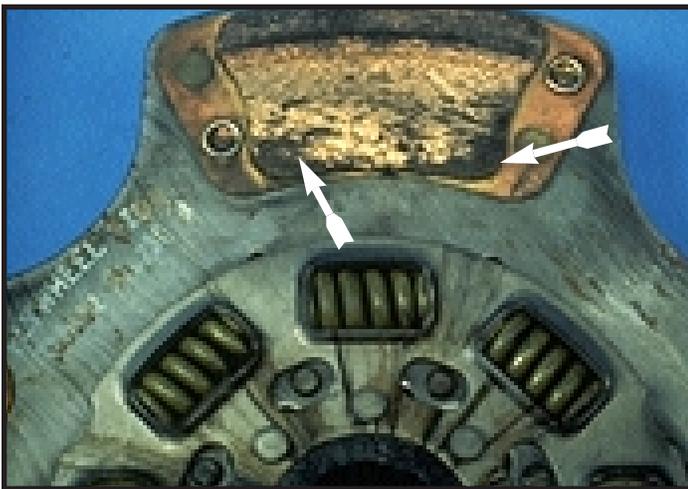
Figure 44

Greasing the splined areas of either the input shaft or disc hub(s) is not recommended because the grease can be flung onto the facing material of the driven disc(s) (refer to both arrows in figure 44). The circled area in figure 45 reveals the numerous paths which the grease took as it moved toward the buttons (facing material) of this ceramic driven disc. The photographs in figures 44-45 are of the same driven disc.

A contaminated driven disc can cause one or more of the following problems:

1. Poor release
2. Clutch chatters during engagement
3. Slipping clutch

NOTE: Eaton does not recommend the reinstallation of driven discs which have become contaminated with grease or oil.

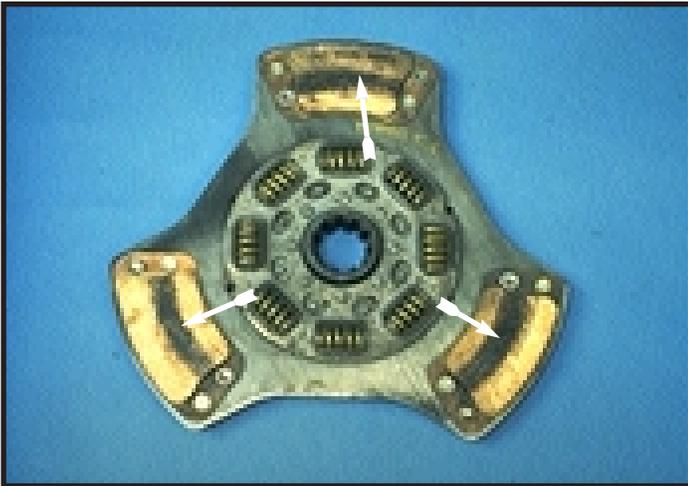
Figure 46

FAILURE—ABNORMAL WEAR PATTERN AT MIDDLE OF DISC BUTTON

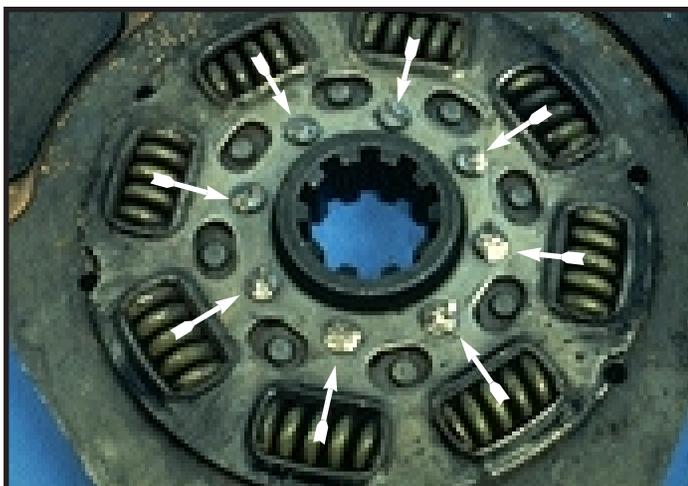
Figure 48

1.) The rivets of the disc (figure 48) have been contacting the flywheel's mounting bolts. Some potential causes of this particular interference are as follows:

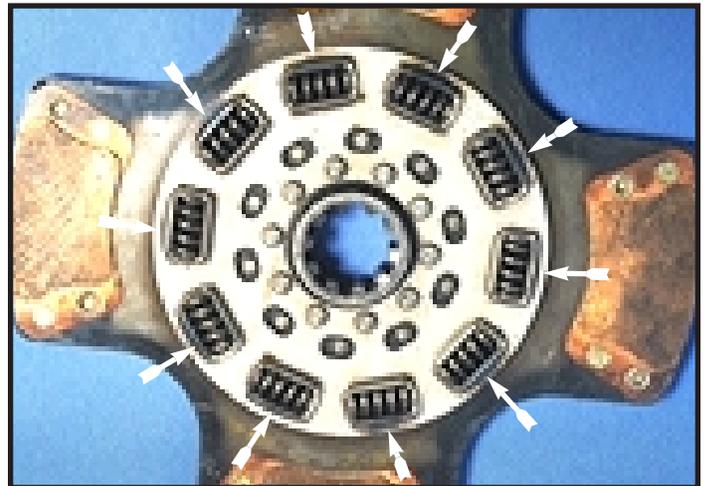
4.) Installation of the wrong clutch. Figure 52 (see arrows) shows the points of interference that resulted when a 10-spring driven disc was installed where an 8-spring was previously being run. In other words, the recessed area of the flywheel (mounting bolt cavity) was too small for the 10-spring driven disc. Before you mount the new clutch, consult the Eaton Installation Instructions (packaged with each Eaton Fuller Clutch) concerning "potential damper interference". A driver complaint, resulting from the above failure, can be:

- 1.) The clutch does not release
- 2.) The clutch is noisy during operation

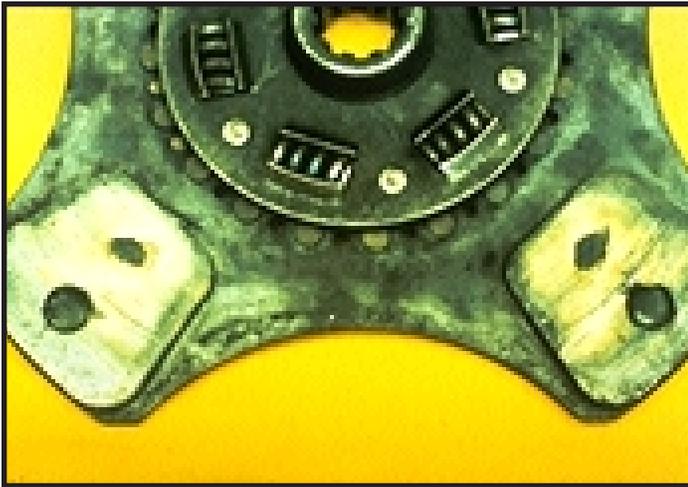
Figure 53: Ceramic Disc

The failures shown in figures 53-56 and 58 are the result of excessive heat due to prolonged slippage. Figures 53, 54, and 58 show discs that became so hot (due to slippage) that the ceramic material began to flow and eventually separate from the disc. Figures 55 and 56 show how the organic material separates from the disc due to bonding agent failure as a result of extreme heat. Burnt discs may result from:

- Lack of free pedal
- Constantly riding the clutch pedal
- Utilizing a slipping clutch as a brake on an incline
- Partial unloading of a clutch due to a binding linkage system, interference, etc.
- Installation and use of improper clutch (wrong application)
- Worn driven disc facings.

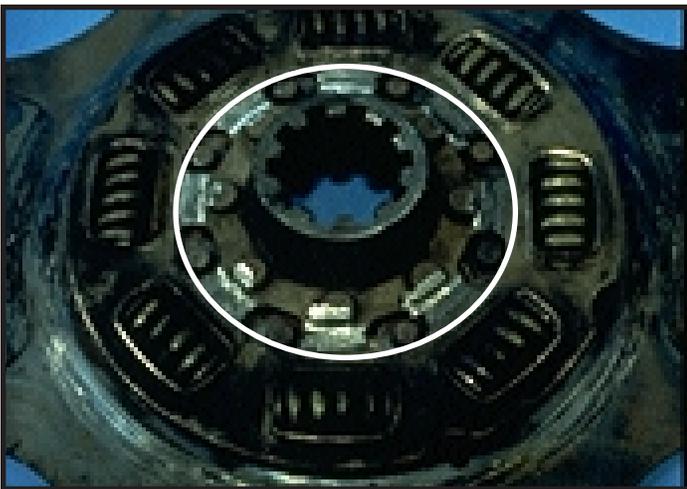
Figure 57: (Close up of Figure 58)

Figure 25 shows the damage done to the nose of the retainer assembly (see white arrow) due to contact with the disc rivets. Figure 57 shows the resulting damage done to the rear disc. Adjusting the clutch externally (with the linkage) instead of internally (rotation of adjusting ring) will cause the retainer sleeve/release bearing assembly to move too far forward as the clutch wears, leading to this failure.

Figure 57 (see circle) shows the damage that will occur to the rear disc when it makes contact with the retainer assembly (refer to the white arrow in figure 25 concerning the subsequent damage to this part) . This type of interference was so great that the clutch began to slip while engaged, thus creating enough heat too cause the ceramic buttons to self-destruct (figure 58).

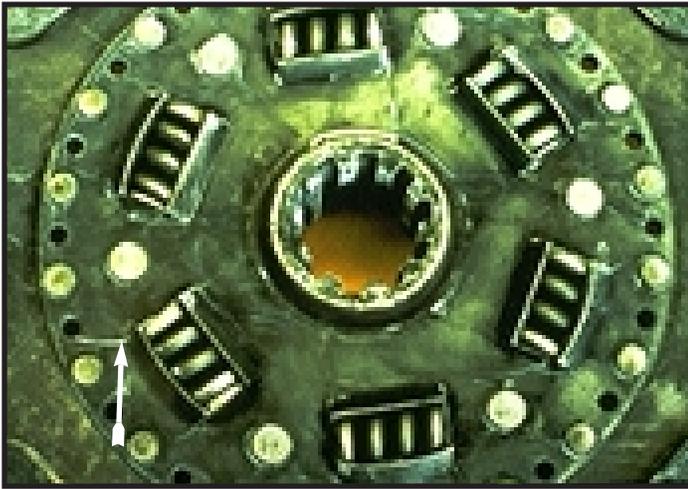
Figure 59

The cracks shown in figures 59 and 60 (see arrows) can result from:

- Forcing the transmission input shaft into the disc hub during installation
- Allowing the transmission to hang unsupported in the driven disc(s) during installation
- Misalignment between the engine housing and the transmission bell housing

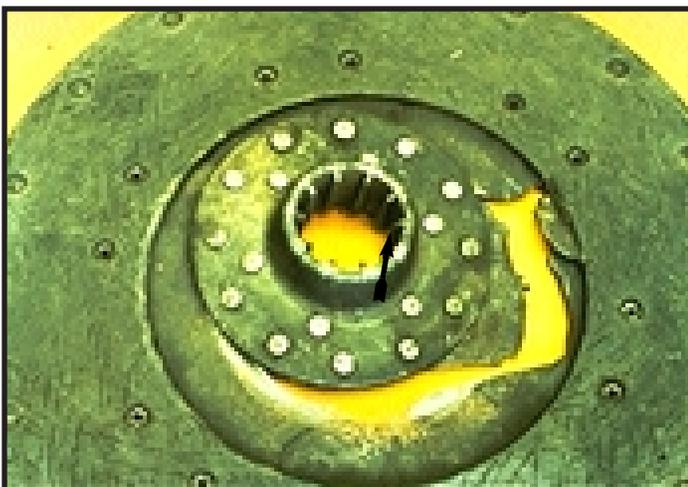
Figure 61 shows a disc hub that has worn excessively (see arrow) and has also broken away from the disc. Note the narrow width of each spline compared with those on a new disc. Figure 62 reveals a hub in which the splines have been completely “pounded” out (see arrow.) The typical cause of worn splines is either torsional vibrations or misapplication of the clutch. A broken or cracked disc hub can be attributed to one or more of the following:

- A severe shock load, such as engaging the clutch while coasting down a hill
- Misalignment between the transmission bell housing and engine housing due to loose transmission mounting bolts and/or worn mating faces of either housing
- Misapplication—a rigid disc should not have been used, but rather a dampened disc assembly (D.D.A.)
- Torsional vibrations from the engine
- Excessive flywheel runout
- Allowing the transmission to hang unsupported in the driven disc during installation.

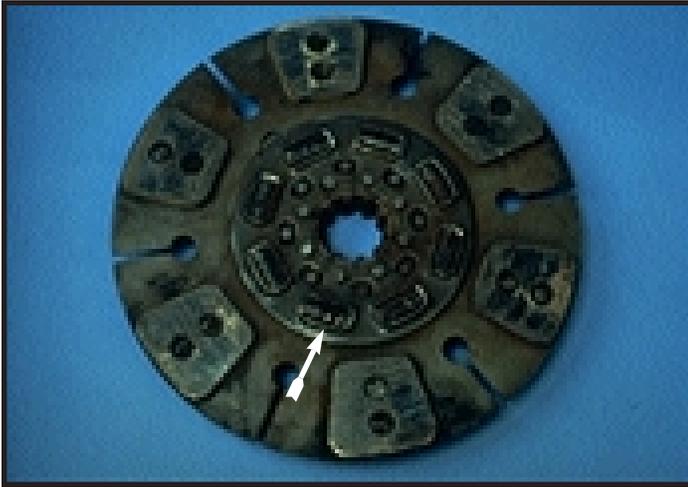
Figure 63 is the disc of a non - Eaton rebuilt clutch. It is an old disc that was rebuilt, as indicated by the presence of dampener springs encased in rubber (see arrow). Consequently, the rubber covered springs can make the disc act as a rigid disc, thus increasing wear to the input shaft and the disc itself. As shown by an arrow in figure 64, parts of this disc have broken. Also, the springs are wrapped in rubber to prevent any worn ones from falling out after the disc is put into service. Contrast this with the Eaton Fuller Reman Clutches in which only new discs are used.

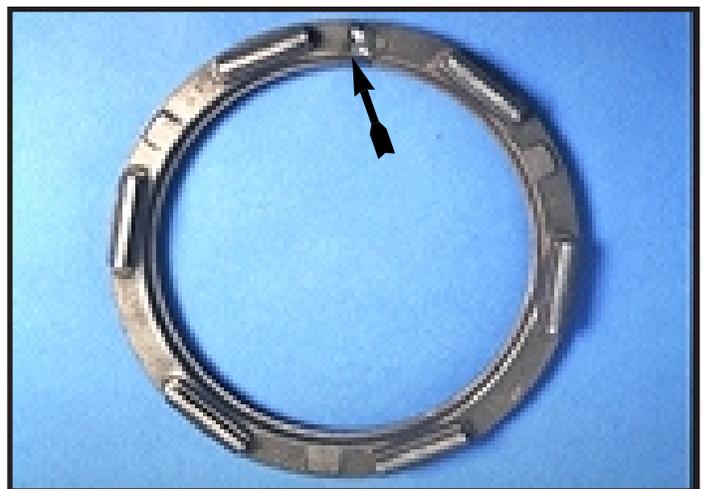
Figure 65

Note also the adjusting ring pictured in figure 65. It was removed from a non-Eaton rebuilt clutch. This ring was cut open on one side, spread apart, and then welded (see arrow) at a larger diameter to prevent the adjusting ring from becoming loose once it was reinstalled. (Eaton Clutch does not weld adjusting rings, but rather discards any rings that are too loose.)

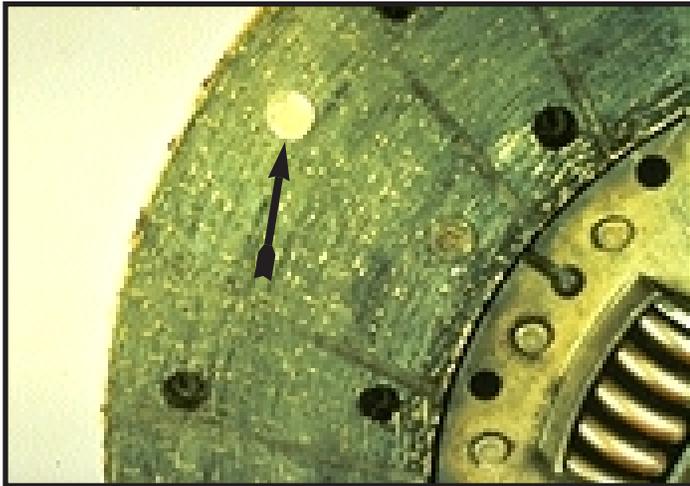
Figure 70

The groove (see arrow in figure 17) worn into the face of this pressure plate was caused by the rivets of the driven disc facing. (For the resultant disc failure, see the description under figure 70). The same damage can occur on both the intermediate plate and flywheel. A surface that is grooved can damage the new driven discs that are installed. As a result, a new clutch assembly should be installed. Refer to the O.E. service manual concerning flywheel resurfacing.

When the rivets (those which secure the facing material to the driven disc) begin to contact either the pressure plate, intermediate plate, or flywheel, then the entire clutch assembly is ready for replacement. Referring to the arrow in figure 70, this rivet has been making contact with the pressure plate shown in figure 17. Note the “shiny” appearance of the rivet and also the resulting “groove” on the pressure plate.

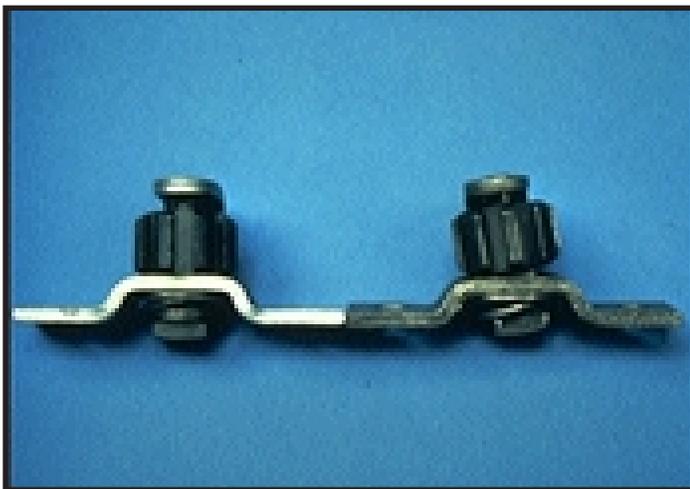
Figure 71

Referring to figure 71, the kwik-adjust mechanism at the left is a normal and properly functioning adjuster while the one at the right has been damaged, as evidenced by the bent mounting bracket. The one pictured in figure 72 also has a bent mounting bracket in addition to some broken gear teeth (see arrow). Some causes of these failures can be:

- Forgetting to depress the kwik adjuster while attempting to rotate the gear.
- Only partially depressing the mechanism while attempting to rotate the gear.
- Attempting to rotate the gear while the clutch pedal is in the up position (clutch is not released).

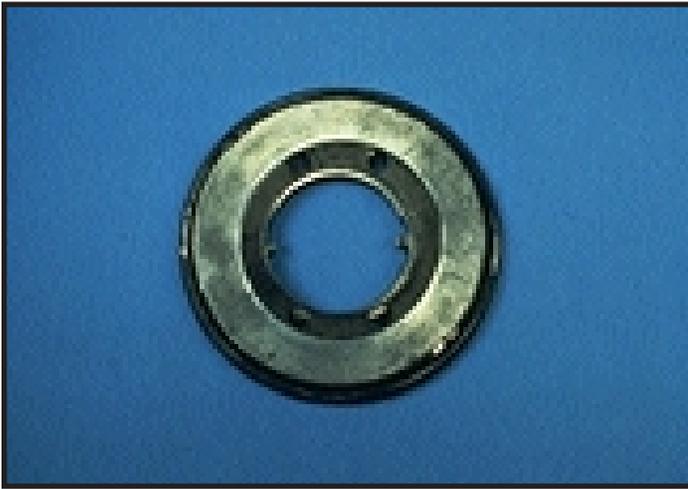
Figure 73: (T.L.C.B.)

FAILURE—WORN CLUTCH BRAKE

As shown in figure 73, the facing material on this clutch brake is completely worn away. Figure 74 shows a clutch brake that is partially worn (see arrows). Both types of failures can be attributed to one or more of the following:

- A clutch that is releasing poorly (for corrective action, see the troubleshooting section titled “Poor Release”), thus making it more difficult for the clutch brake to stop the transmission input shaft.
- “Hitting” or engaging the clutch brake when the transmission is in gear and the vehicle is in motion and/or
- The clutch brake was set too high.
- Installing the new clutch brake in front of a worn/rough transmission bearing retainer cap.
- Clutch brake is simply worn out.

A worn clutch brake should be replaced. Be sure to always check the transmission bearing retainer cap for any wear and replace if necessary (see figure 3).

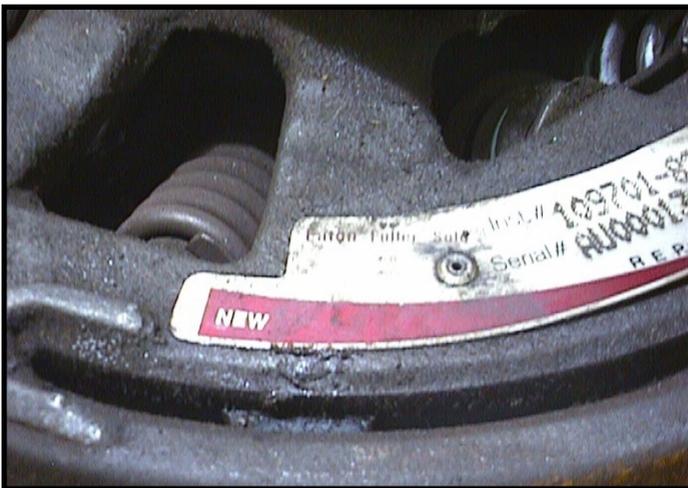
Figure 75

FAILURE—SOLO CAM TAB BROKEN OFF

In Figure 75, the tab was broken when someone was attempting to change the adjustment of the clutch. The clutch cannot break the tab. Many times the tab is broken to change the bearing to clutch brake distance when it is in the proper position. Do not attempt to change the clutch adjustment before measuring the release bearing to clutch brake distance.

Consult the troubleshooting guides for help. If the release bearing is set to the correct dimension, do not attempt to use the cam tab to change the adjustment to the wrong dimension and break off the tab.

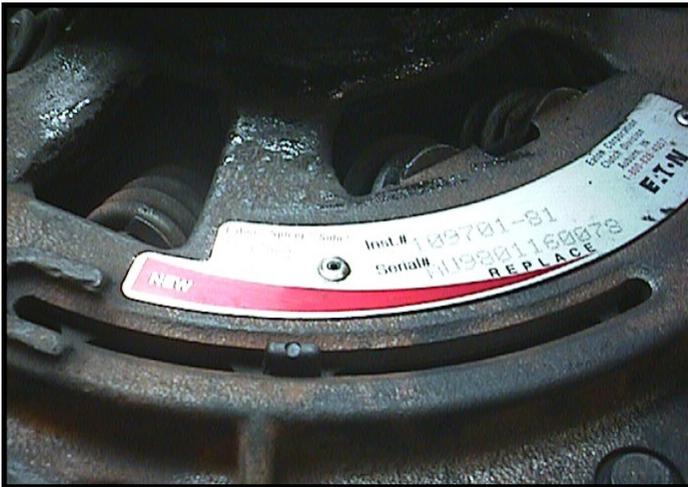
Figure 76

FAILURE—SOLO OVER ADJUST PROBLEM

Measure the distance between the release bearing and clutch brake. Correct distance should be between .490" and .560" with the pedal up (figure 76). If the bearing is close to the clutch brake and the clutch has not been removed and re-installed on the flywheel, then an overadjust might have occurred. Consult troubleshooting guides for help. Follow the fault tree for proper diagnosis and correction.

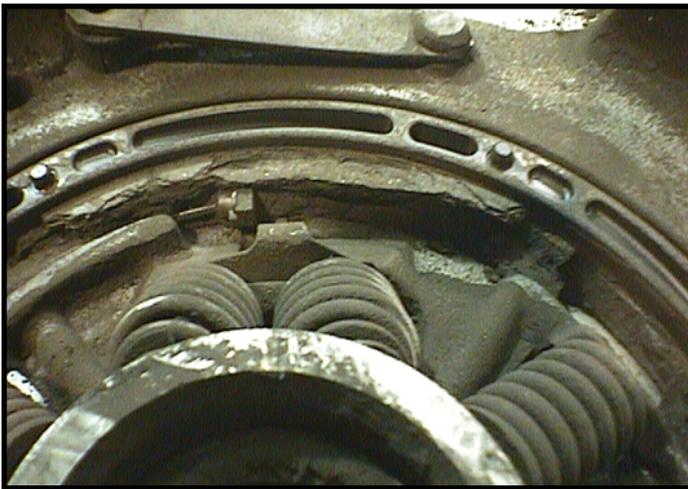
Figure 80

FAILURE—SOLO ADJUSTMENT RINGS CONTAMINATED—SOLO STOPS ADJUSTING

If there is excessive amounts of contamination allowed into the clutch housing, the Solo may stop adjusting and there will be a loss of free pedal in the cab (see figure 80). Has the inspection cover been removed? In severe dust applications, it may require to seal all openings in the clutch housing.

Eaton has created a tool that may help free up the clutch to allow it to continue adjusting. #CLPISOLOTOOL CAN BE OBTAINED BY CALLING 888-386-4636.

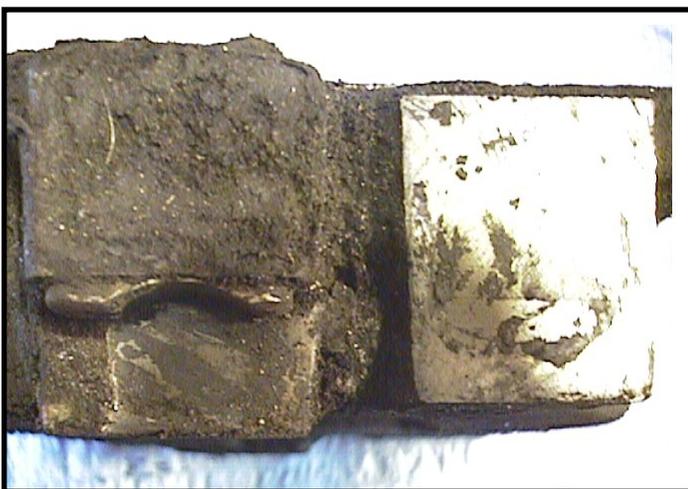
Figure 81

FAILURE—WORN WEAR PAD ON RELEASE BEARING CAUSED BY RUNNING THE TRUCK WITHOUT FREE PEDAL

When the clutch is properly maintained, there should always be free pedal in the cab. This will prevent fork contact with the bearing wear pads and reduce the wear to the pads and the release fork (figure 81). Follow adjustment instructions for correct clutch and linkage adjustment. Adjust the clutch before free pedal is lost. Apply grease to the yoke fingers to reduce friction when the clutch pedal is stroked.

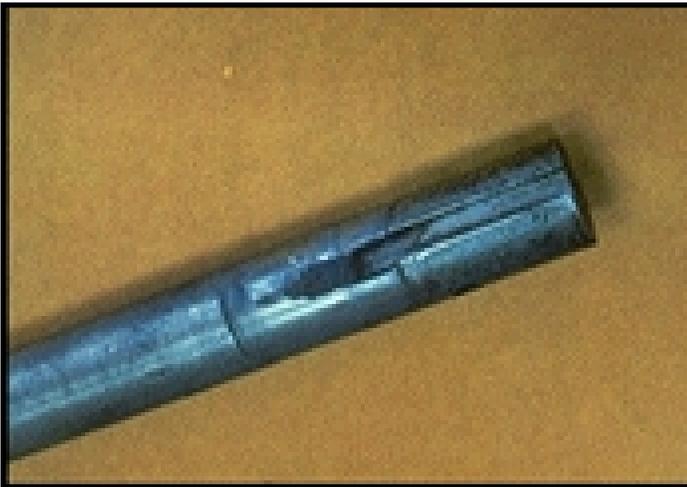
FAILURE—CROSS SHAFT WEAR

Figure 82 is an example of a worn cross shaft (release shaft). A worn cross shaft (see circle) will occur after high mileage and will be accelerated by a lack of lubrication. Some problems associated with worn cross shafts (and/or worn linkage systems) are as follows:

- Sporadic changes in the amount of free play in the cab
- A binding condition in the linkage system
- Erratic engagement of the clutch
- Side loading of the release bearing housing.

As a result, a typical complaint might be that it is impossible to maintain proper clutch adjustment. To prevent future clutch problems, always inspect the linkage system for excessive wear and/or binding conditions before installing the new clutch. Be sure to replace any worn components that might hinder clutch operation. Also, remember to lubricate the linkage pivot points.

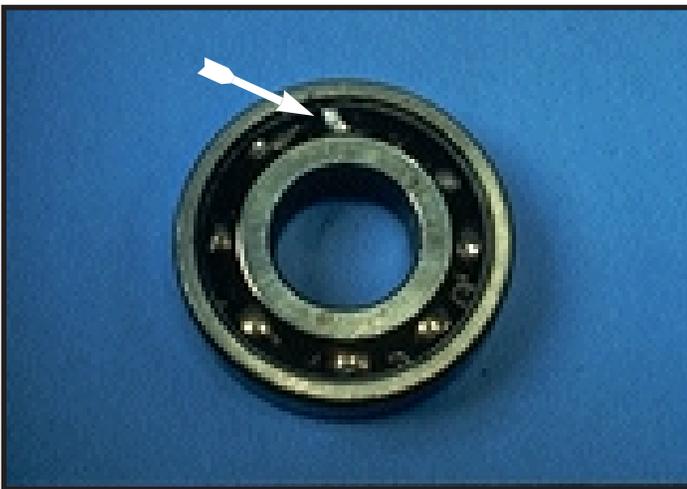
Figure 83

FAILURE—SEIZED/DRY PILOT BEARING

Once removed from the flywheel, a failed pilot bearing can be identified by one or more of the following conditions:

- The bearing is dry - it is difficult to turn (rough) or completely seized. Any condition which causes a dry bearing will have been accompanied by a noise complaint while it was in the vehicle.
- A damaged ball bearing cage (see arrow in figure 83.)
- A step is worn into the inner race. The step is caused when the input shaft spins within the inner race, a direct result of the seized pilot bearing.
- The seal is missing and/or damaged because of excessive heat generated by the dry bearing.

A typical complaint associated with a failed pilot bearing (other than noise) is poor release. Poor release can be the result of one or more of the following conditions:

- The outer race of the bearing fits too tightly in the flywheel.
- The inner race of the bearing fits too tightly on the input shaft.
- A seized or rough pilot bearing will allow the input shaft to continue rotating even when the clutch is completely disengaged. As a result, the clutch brake can become damaged and eventually fail. (see figure 73 of "Worn Clutch Brake")
- If the bearing fits too loose, the end of the input shaft won't be properly fitted. Also, if the fit is loose, the races will skid rather than rotate the ball bearings.

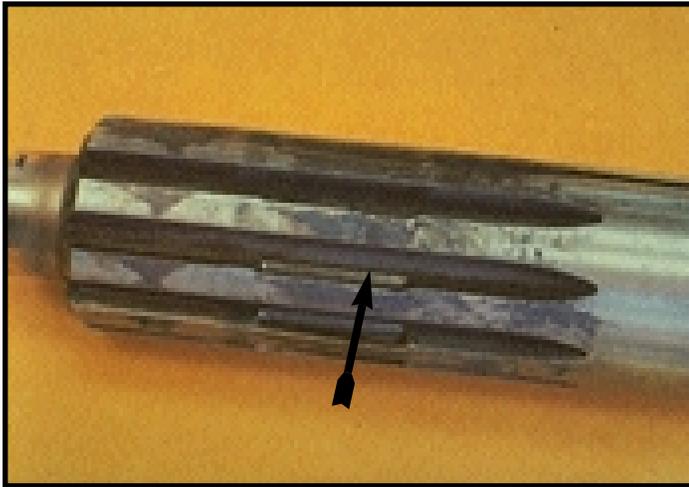
Figure 84

FAILURE—INPUT SHAFT (DRIVE GEAR) SPLINE WEAR

Drive gear spline wear will cause clutch release problems since the driven discs can't slide freely on the splines. This is especially true if new driven discs are installed on a worn input shaft (figure 84). Excessive spline wear can be attributed to torsional vibrations. This type of wear can be eliminated or lessened by the use of dampened driven discs. Spline wear will also occur on the mating driven disc hubs (see figures 61-62). Misalignment can also be a factor in abnormal spline wear. It is important to always inspect the input shaft for wear before installing a new clutch. If worn, it is recommended that a new input shaft be installed to eliminate possible clutch problems later on.

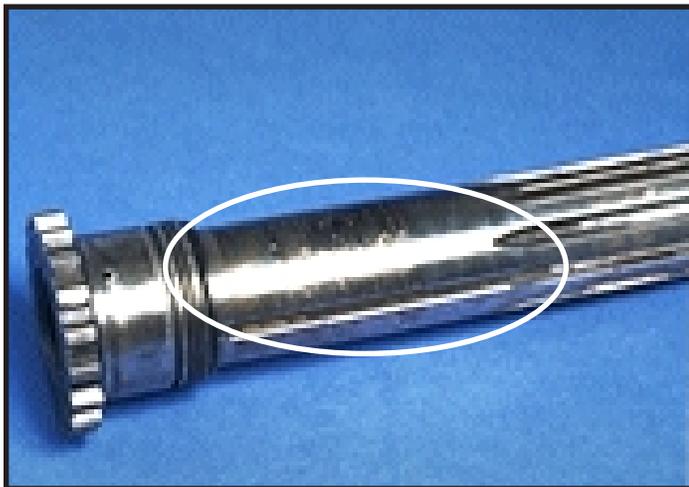
Figure 85

FAILURE—GALLED INPUT SHAFT

This failure resulted when the clutch's release sleeve was being "side loaded" onto the input shaft (figure 85). A worn linkage system and/ or excessive wear on the release bearing "wear pads" and "release yoke fingers" can cause this side loading condition.

A galled or rough input shaft (in the non-splined area) will damage the bushing(s) of not only the original clutch, but also that of the newly installed clutch. As a result, make sure you replace the input shaft and any worn linkage components to prevent the failure from being repeated.

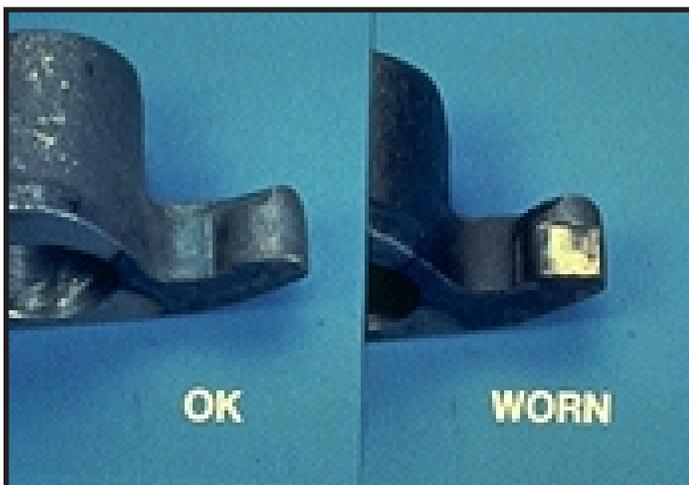
Figure 86

FAILURE—WORN FINGERS ON RELEASE YOKE
